**USS TAYLOR (FFG-50)**  
**HULL MECHANICAL ELECTRICAL READINESS**  
**ASSESSMENT**  
**SHELL CONDITION SURVEY**  
**OF INTERIOR AREAS**  
**02/18/03 TO 02/27/03**

**USS TAYLOR (FFG-50)**  
**SHELL CONDITION ASSESSMENT SURVEY, INTERIOR AREAS.**

A HM& ERA UNDERWATER HULL AND SUPPORTING STRUCTURE SURVEY OF INTERIOR AREAS WAS CONDUCTED ON BOARD **USS TAYLOR (FFG-50)** FROM 02/18/03 TO 02/27/03 AT NAVAL STATION MAYPORT, FLORIDA.

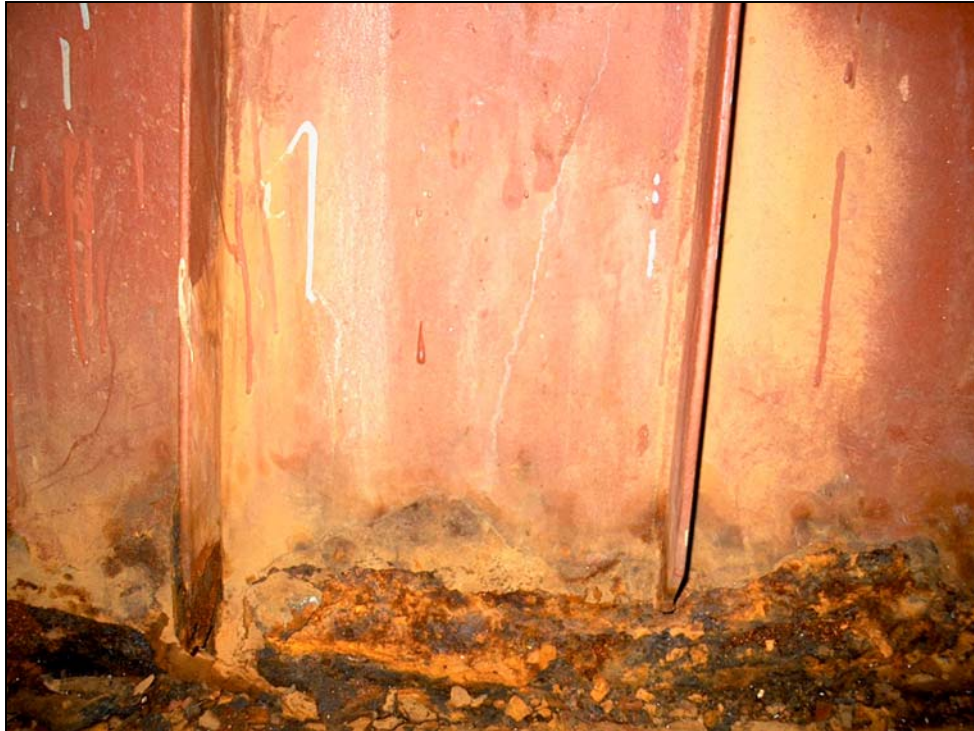
LOCATION	AREA	RESULTS
5-292-0-E AMR 3 CSMP A162	PORT SIDE, BETWEEN BHD 328 AND FRAME 324	APPROX 8 SF OF MARGIN PLATE IS THINNING BELOW THE 25% WASTAGE CRITERIA. APPROX 60 SF FROM MARGIN PLATE TO STRINGER (12) HAS HEAVY CORROSION AND PAINT SEPARATION.
5-292-0-E AMR 3 JSN-A339	PORT SIDE FRAME 324	FRAME324 IS DETERIORATED AT THE JUNCTION OF THE SHELL AND MARGIN PLATE
5-250-0-E MER JSN- A346	PORT SIDE BETWEEN FRAMES 264 AND 270	3 <sup>RD</sup> , 4 <sup>TH</sup> , AND 5 <sup>TH</sup> STRINGERS FROM THE MARGIN PLATE ARE HOLED
5-250-0-E MER JSN A427	STARBOARD SIDE, FROM MARGIN PLATE TO 3 <sup>RD</sup> STRINGER ABOVE THE LOWER LEVEL DECK.	200 SQFT OF SATURATED HULL INSULATION AND CORROSION
5-212-0-E AMR 2 JSN-A341	STARBOARD SIDE STRINGER 8 BETWEEN BHD 212 AND FRAME 220.	STRINGER 8 IS HOLED BELOW OVBD DISCHARGE
5-212-0-E AMR 2 JSN A344	PORT AND STARBOARD, FROM BULKHEAD (212) TO FRAME 278	SATURATED INSULATION AND CORROSION PORT SIDE CORROSION STARBOARD SIDE

SEVERELY CORRODED MARGIN PLATE BETWEEN FRAMES 324 AND 328  
SEVERAL U/T READINGS ARE BELOW THE 25% WASTAGE CRITERIA.  
REFER TO DRAWING. CSMP A162.

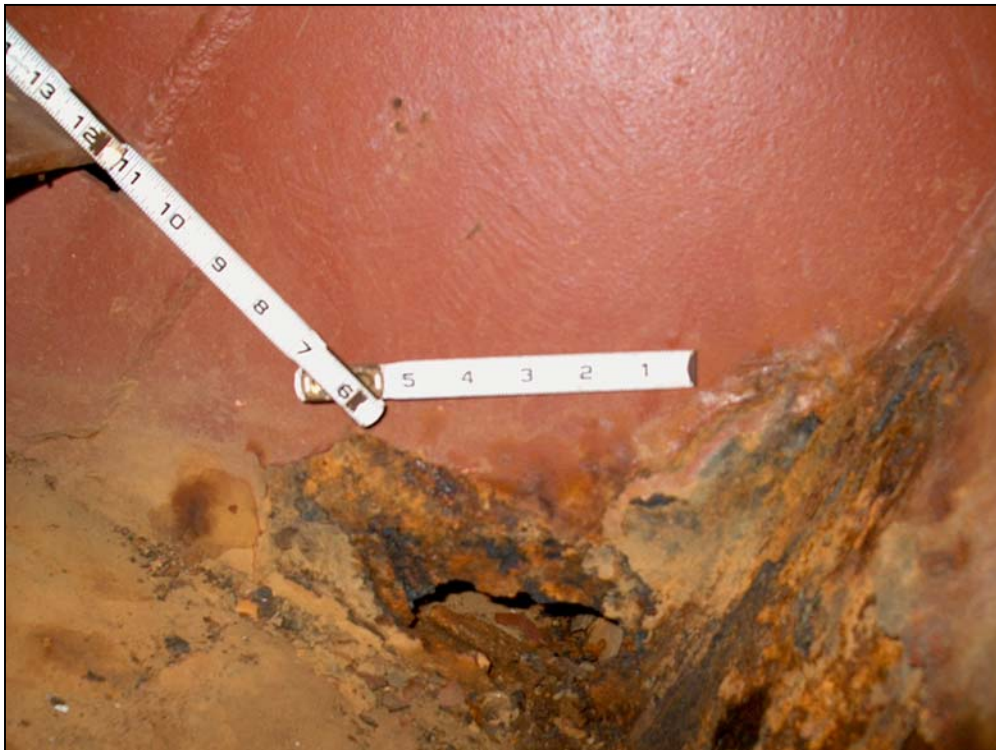
DISCREPANCY DESCRIPTION: PER HM&ERA UNDERWATER HULL ASSESSMENT: 5-292-0-E AMR3 PORT SIDE, THE WEB OF FRAME 324 IS SEVERELY DETERIORATED AT THE JUNCTION OF THE MARGIN PLATE AND THE SHELL.					
RECOMMENDED REPAIRS: IN CONJUNCTION WITH REPAIRS TO MARGIN PLATE (CSMP-A162) CROP OUT AND REPLACE APPROX. 1 SQFT OF FRAME 324 WITH .250 OS. REFER TO NAVSHIPS DRAWING NO. 5534342 REV A SHEET 16					
SSPORT C221 POC: B. WILLIAMS (757-396-4001 EXT-2166 ) TPOC: C. BUCK					
CSMP SUMMARY: FRAME 324 PORT, DETERIORATED 5-292-0-E				TEST# MRC 1102/1	
ROOT CAUSE/AMPLIFICATION: H1				STEP# 1 THRU 5	
SYSTEM LEVEL IMPACT:					
PART NO.	NOMENCLATURE		QTY	NSN	COST
1					
2					
3					
4					
5					
6					
FIRST CONTACT GUEVERA	RATE DC1	SECOND CONTACT REYES		RATE DCC	PHONE
ASSESSOR / ACT / TECH ID# J. LAROCK QED SYSTEMS INC			TD	TL	LOGISTICIAN TSP

LOOKING FORWARD AT FRAME 324. THE WEB IS SEVERELY DETERIORATED.  
JSN A339

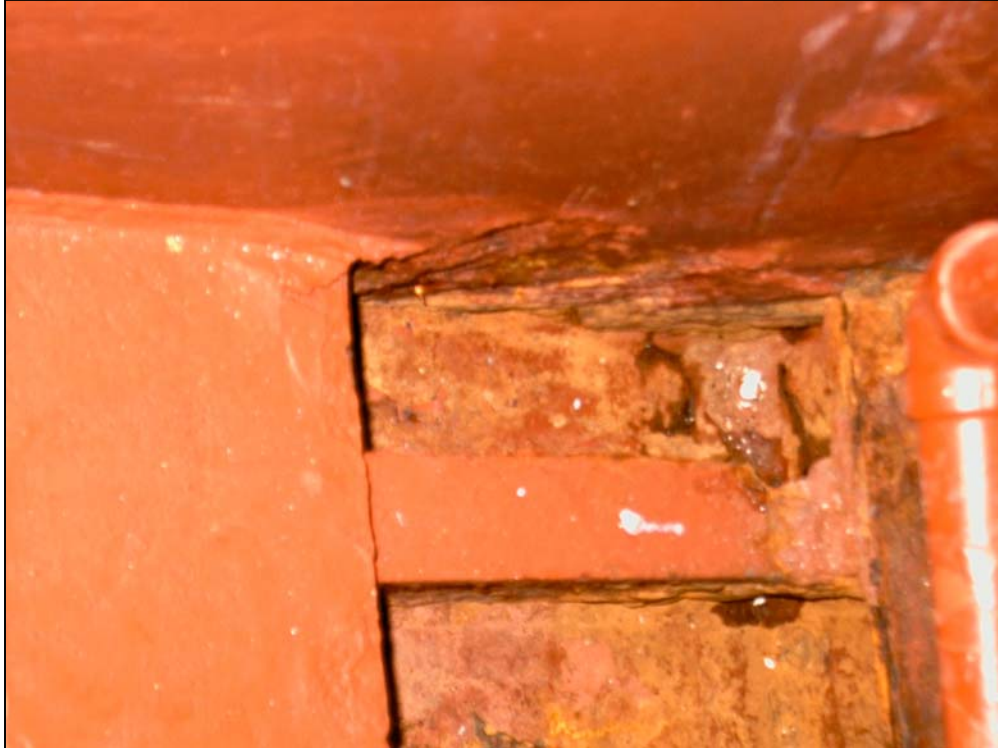
CORROSION IN BILGE AT FRAME 316 PORT SIDE. CSMP A162

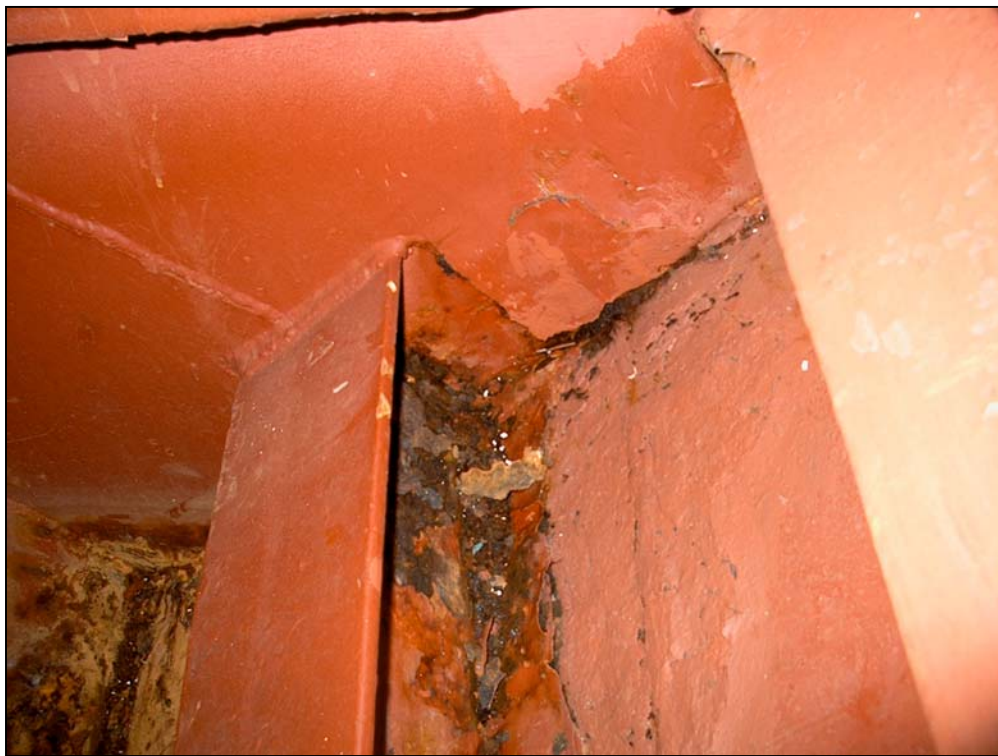
CORROSION ON SHELL AND STRINGERS AT FRAME 324 LOOKING AFT.  
CSMP A162

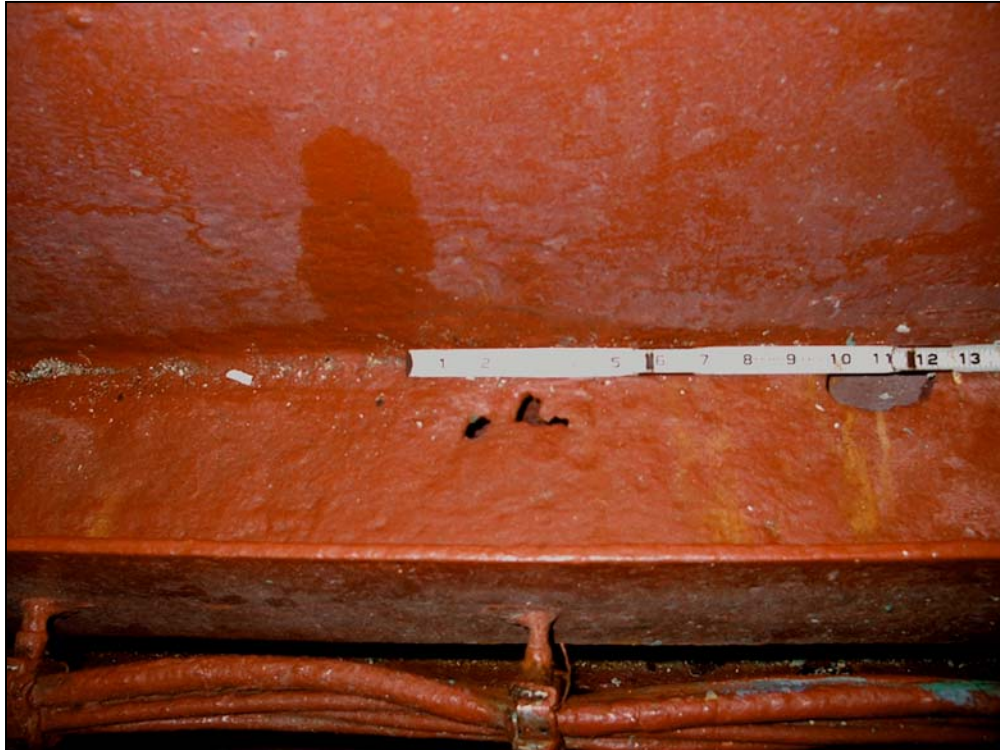
HOLED STRINGER (5<sup>TH</sup> FROM THE MARGIN PLATE) APPROXIMATELY  
2 FEET FORWARD OF FRAME 270, PORT SIDE JSN. A341

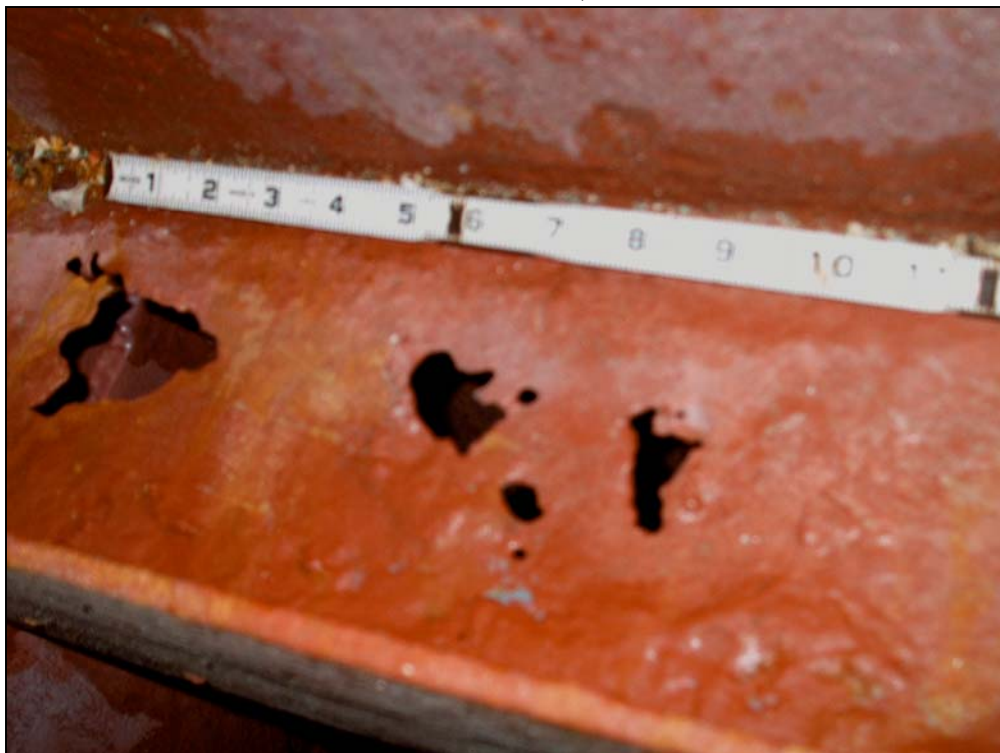
4<sup>TH</sup> STRINGER FROM THE MARGIN PLATE AT FRAME 270, PORT SIDE.

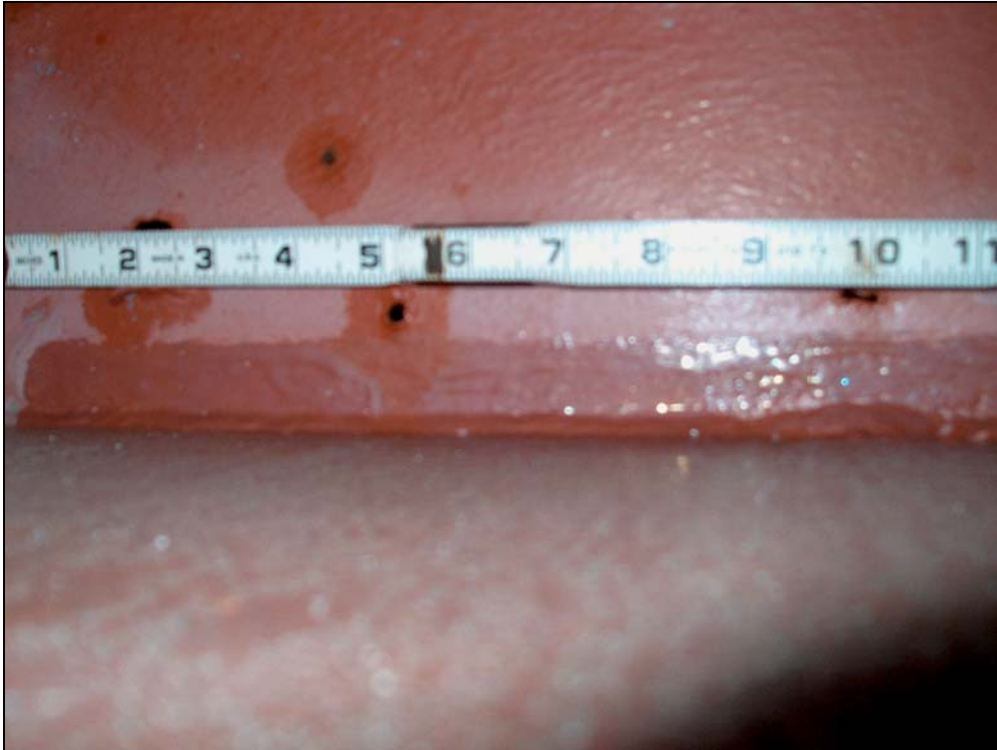
<b>DISCREPANCY DESCRIPTION: PER HM&amp;ERA UNDERWATER HULL ASSESSMENT: 5-250-0-E MAIN ENGINE ROOM PORT SIDE</b>					
THE 3 <sup>RD</sup> , 4TH AND 5 <sup>TH</sup> STRINGERS FROM THE MARGIN PLATE ARE HOLED IN SEVERAL PLACES BETWEEN FRAMES 264 AND 270.					
<b>RECOMMENDED REPAIRS: CUT OUT ALL THREE STRINGERS FROM 1-FOOT FWD OF FRAME 264 TO 1 FOOT AFT OF FRAME 270.</b>					
REPLACE WITH (6X6 ½ T BEAM). APPROX 24 LINEAR FEET. PRIME AND PAINT . REFER TO NAVSHIPS DRAWING 553431 REV A					
<b>SSPORT C221 POC: B. WILLIAMS (757-396-4001 EXT-2166 ) TPOC: C. BUCK</b>					
<b>CSMP SUMMARY: HOLED STRINGERS, MER</b>				<b>TEST#</b> MRC 1102/1	
<b>ROOT CAUSE/AMPLIFICATION:</b> H1				<b>STEP#</b> 1 THRU 5	
<b>SYSTEM LEVEL IMPACT:</b>					
PART NO.	NOMENCLATURE		QTY	NSN	COST
1					
2					
3					
4					
5					
6					
FIRST CONTACT GUEVERA		RATE DC1	SECOND CONTACT REYES		RATE DCC
ASSESSOR / ACT / TECH ID# J. LAROCK QED SYSTEMS INC			TD	TL	LOGISTICIAN

3<sup>RD</sup> STRINGER FROM THE MARGIN PLATE IS HOLED IN SEVERAL PLACES BETWEEN  
FRAMES 264 AND 270, PORTSIDE. JSN A346

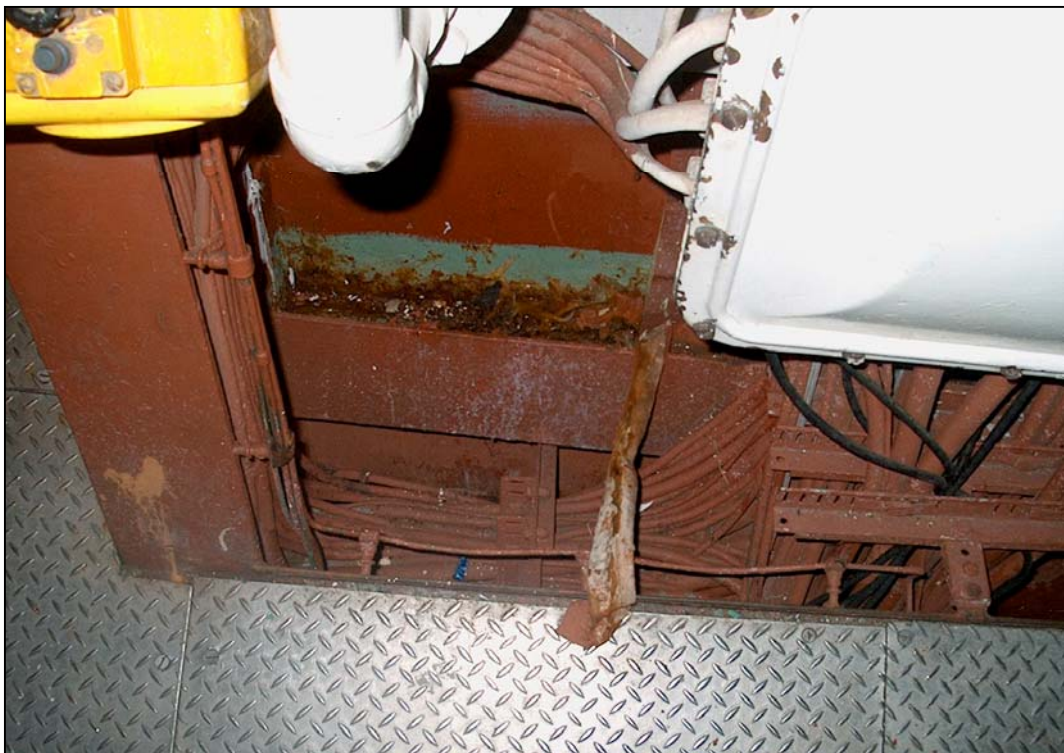
<b>DISCREPANCY DESCRIPTION: PER HM&amp;ERA 2 UNDERWATER HULL ASSESSMENT: 5-250-0-E MAIN ENGINE ROOM STARBOARD</b>					
SIDE BETWEEN BHD 250 AND FRAME 278. HULL INSULATION FROM 3 <sup>RD</sup> STRINGER ABOVE DECK DOWN INTO BILGE APPROX.200					
SQFT IS SATURATED AND HIDING CORROSION, CORROSION RUNS TO AND INCLUDES THE MARGIN PLATE APPROX 400 SQFT.					
<b>RECOMMENDED REPAIRS: REMOVE APPROX. 200 SQFT OF HULL INSULATION, REMOVE CORROSION FROM 3<sup>RD</sup> STRINGER ABOVE DECK TO AND INCLUDING THE MARGIN PLATE, PRIME AND PAINT APPROX. 400 SQFT OF AREA. REPLACEMENT OF THE INSULATION IS NOT RECOMMENDED.</b>					
<b>SSPORT C221 POC: B. WILLIAMS (757-396-4001 EXT-2166 ) TPOC: C. BUCK</b>					
<b>CSMP SUMMARY: SATURATED INSULATION ,CORROSION STBD, MER</b>				<b>TEST#</b> MRC 1102/1	
<b>ROOT CAUSE/AMPLIFICATION:</b> H1				<b>STEP#</b> 1 THRU 5	
<b>SYSTEM LEVEL IMPACT:</b>					
PART NO.	NOMENCLATURE		QTY	NSN	COST

STARBOARD SIDE, FRAME 264. CORROSION ON THE SHELL AND STRINGER THAT WAS HIDDEN BY THE HULL INSULATION. PERMANENT REMOVAL OF THE INSULATION FROM BULKHEAD 250 TO FRAME 278 IS RECOMMENDED. THIS IS A HIGH CORROSION AREA ON THE FFG-7 CLASS. JSN A427

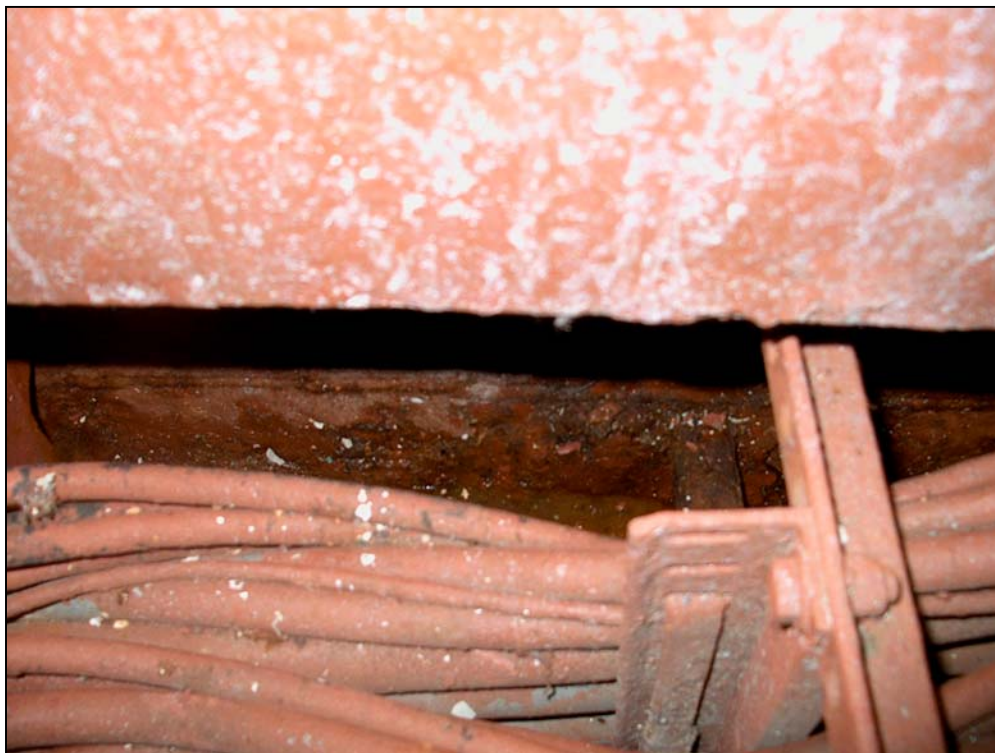
CORROSION ON DECK LEVEL STRINGER AFT OF FRAME 264. JSN A427

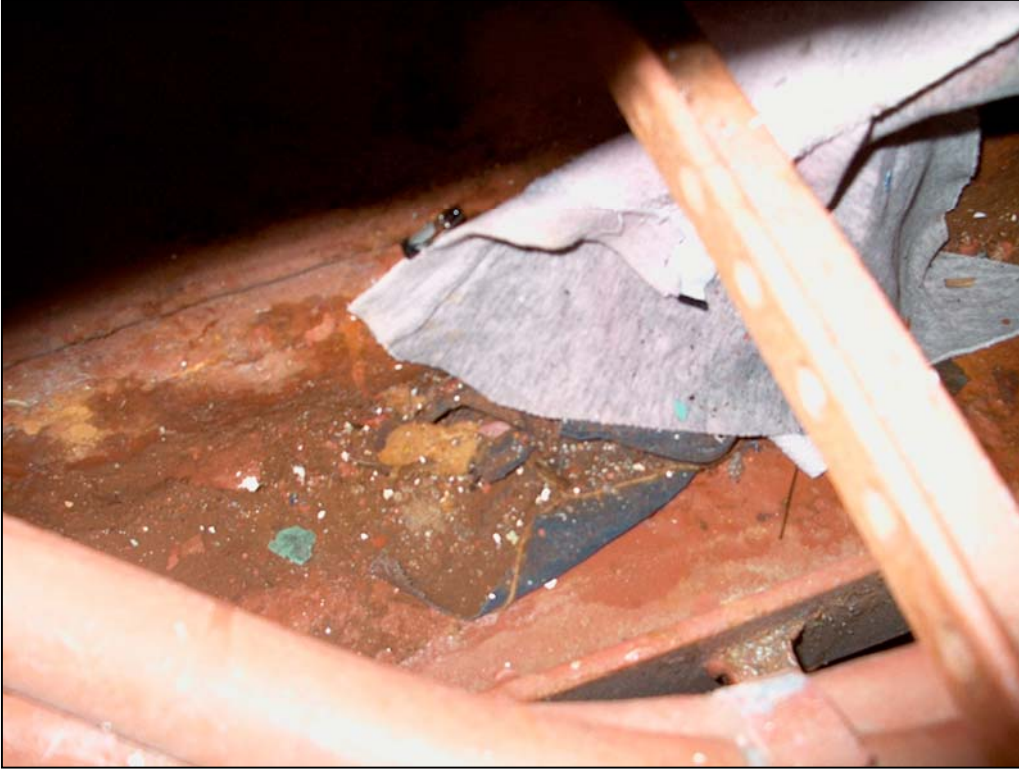
CORROSION ON DECK LEVEL STRINGER FORWARD OF FRAME 264. JSN-A427

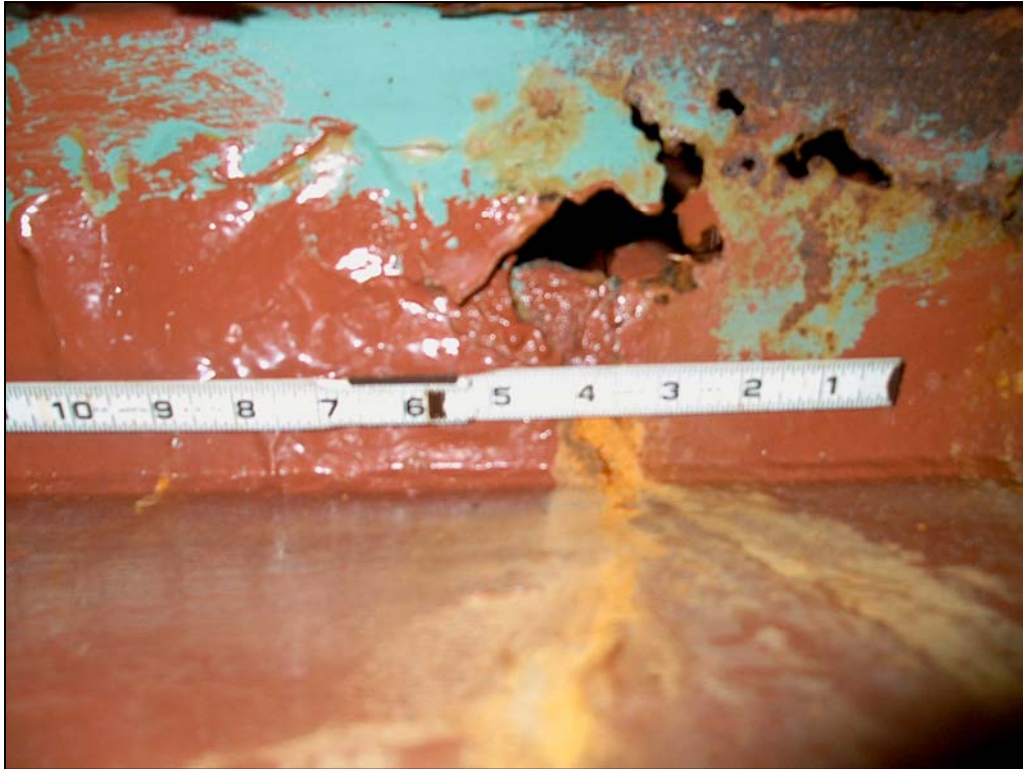
DISCREPANCY DESCRIPTION: PER HM&ERA UNDERWATER HULL ASSESSMENT: 5-212-0-E AMR 2 STARBOARD SIDE, STRINGER 8					
IS HOLED BELOW OVBD DISCHARGE BETWEEN BHD 212 AND FRAME 220.					
RECOMMENDED REPAIRS: CUT OUT APPROX 3 FEET OF STRINGER 8 STARTING FROM 18" FORWARD OF OVBD					
DISCHARGE, REPLACE WITH (6X6 1/2 T-BEAM ). PRIME AND PAINT. REFER TO NAVSHIPS DRAWING 553431 REV A.					
SSPORT C221 POC: B. WILLIAMS (757-396-4001 EXT-2166 ) TPOC: C. BUCK					
CSMP SUMMARY: DETERIORATED STRINGER AMR2				TEST# MRC 1102/1	
ROOT CAUSE/AMPLIFICATION: H1				STEP# 1 THRU 5	
SYSTEM LEVEL IMPACT:					
PART NO.	NOMENCLATURE		QTY	NSN	COST
1					
2					
3					
4					
5					
6					
FIRST CONTACT GUEVERA	RATE DC1	SECOND CONTACT REYES		RATE DCC	PHONE
ASSESSOR / ACT / TECH ID# J. LAROCK QED SYSTEMS INC			TD	TL	LOGISTICIAN TSP

STRINGER 8 BELOW OVERBOARD DISCHARGE, BETWEEN BHD 212 AND FRAME 220  
STARBOARD SIDE. JSN A 341

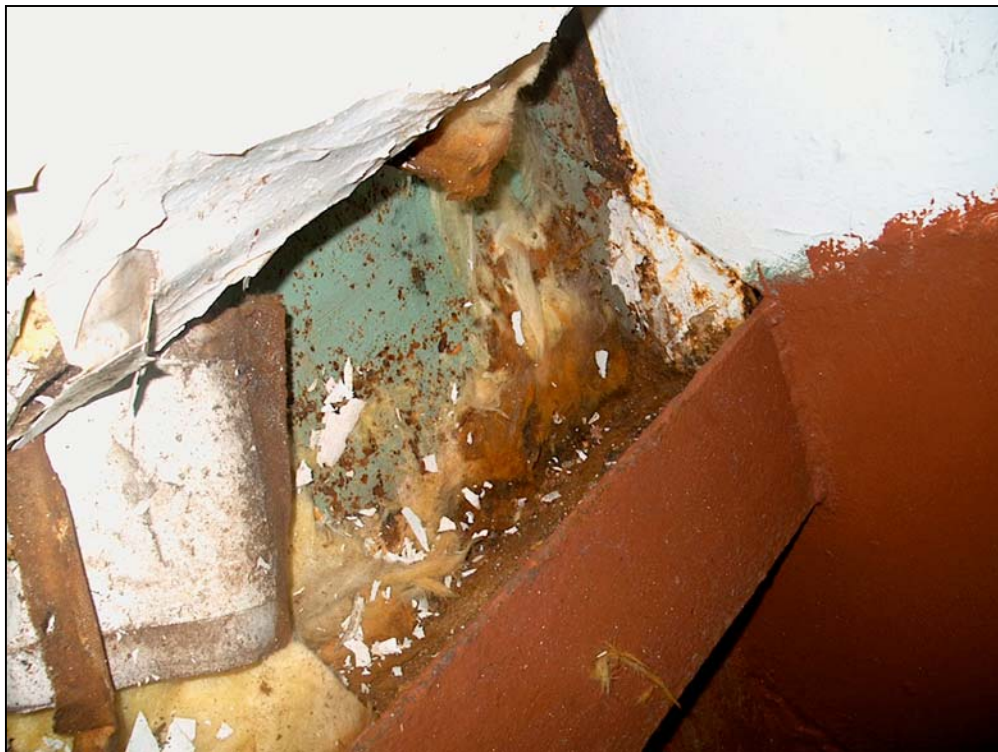
<b>DISCREPANCY DESCRIPTION: PER HM&amp;ERA UNDERWATER HULL ASSESSMENT: 5-212-0-E) AMR2 PORT AND STARBOARD.</b>					
STRINGERS 10 & 11 PORT SIDE UPPER LEVEL OUT BOARD OF THE HPAC BETWEEN BHD 212 & FRAME 228					
HAVE HEAVY PAINT SEPARATION AND CORROSION. HULL INSULATION ON THE STARBOARD SIDE FROM STRINGER 9 TO UPPER					
LEVEL DECK BETWEEN BHD 212 & FRAME 228 IS SATURATED AND HIDING CORROSION. APPROX 120 SQFT					
<b>RECOMMENDED REPAIRS: REMOVE INSULATION AND CORROSION ON THE STARBOARD SIDE, APPROX 120 SQFT. REMOVE</b>					
<b>CORROSION ON THE PORT SIDE, APPROX. 20 SQFT. PRIME AND PAINT AREAS ON BOTH SIDES. REPLACEMENT OF THE</b>					
<b>INSULATION IS NOT RECOMMENDED</b>					
<b>SSPORT C221 POC: B. WILLIAMS (757-396-4001 EXT-2166 ) TPOC: C. BUCK</b>					
<b>CSMP SUMMARY: CORROSION PORT AND STBD AMR2</b>				<b>TEST#</b> MRC 1102/1	
<b>ROOT CAUSE/AMPLIFICATION:</b> H1				<b>STEP#</b> 1 THRU 5	
<b>SYSTEM LEVEL IMPACT:</b>

SATURATED HULL INSULATION AND CORROSION, STARBOARD SIDE AT FRAME 220.  
PERMANENT REMOVAL OF INSULATION FROM BHD 212 TO FRAME 228 IS  
RECOMMENDED. JSN A 344

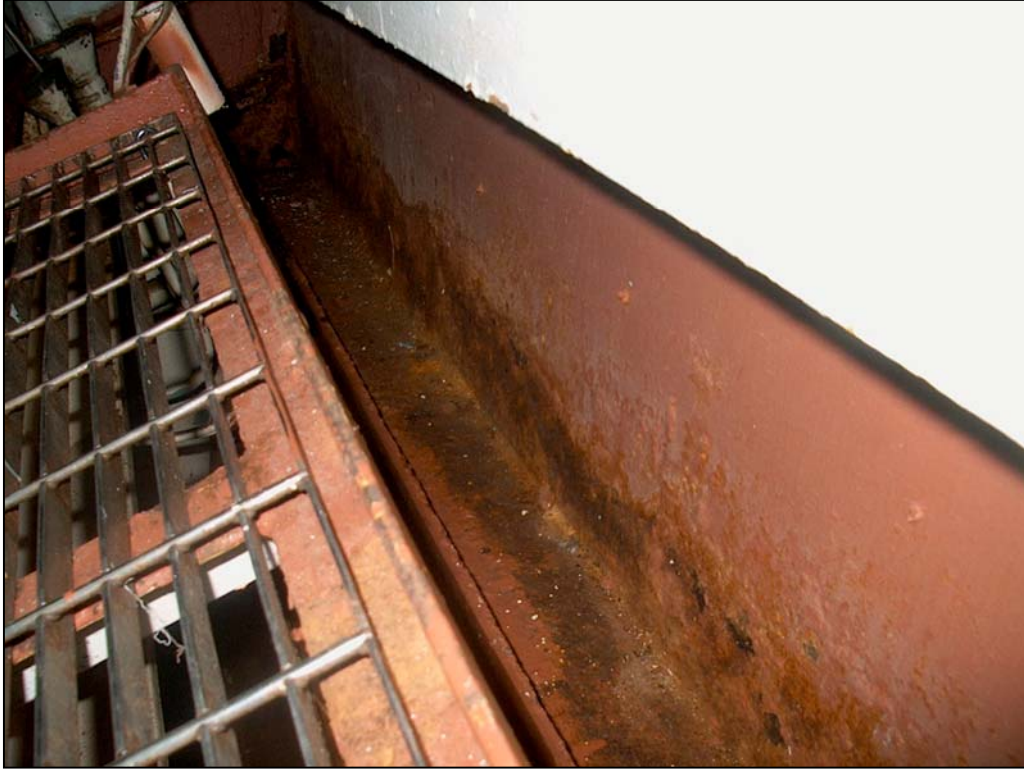
CORROSION ON STARBOARD SIDE, UPPER LEVEL OUTBOARD OF THE HPAC  
BETWEEN BHD 212 AND FRAME 220. JSN A344

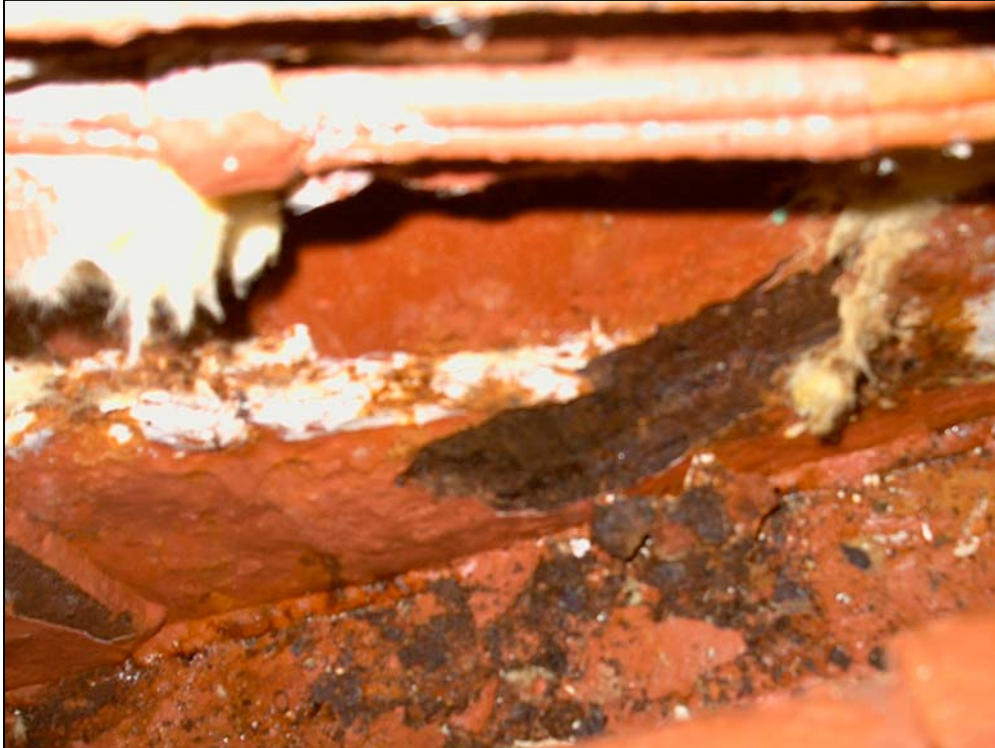
CORROSION ON BHD 204. (CSMP A174) U/T READINGS REVEALED NO SIGNIFICANT LOSS.

MAN HRS EXPENDED	MAN HRS REMAINING	COMPLETED ACTION TAKEN		S/F MANHOURS	PRIORITY		
SAFETY HAZARD: 1. SERIOUS - CORRECT AS SOON AS POSSIBLE 2. SERIOUS - SUSPENSION OF EQUIPMENT/SYSTEM/SPACE REQUIRED 3. SERIOUS - WAIVER OF EQUIPMENT/SYSTEM 4. SAFETY ITEM - MINOR 5. COMBUSTIBLE MATERIAL		1. MAINTENANCE ACTION COMPLETED: PARTS DRAWN FROM SUPPLY 2. MAINTENANCE ACTION COMPLETED: REQUIRED PARTS NOT DRAWN FROM SUPPLY 3. MAINTENANCE ACTION COMPLETED: NO PARTS REQUIRED 4. CANCELLED - DEFERRAL WILL BE REMOVED FROM CSMP 7. MAINTENANCE ACTION COMPLETED: 3-M CAPABILITY UTILIZED 0. NONE OF THE ABOVE, DESCRIBE IN REMARKS/DESCRIPTION SECTION			1. MANDATORY 2. ESSENTIAL 3. <b>HIGHLY DESIRABLE</b> 4. DESIRABLE  <b>3</b>		
PER SEMAT II- PORT SIDE, (5-180-0-E) AUX 1 AREAS OF CORROSION WERE FOUND UNDER REEFER COMPRESSOR#2, UNDER HALON BOTTLE STATION AND INBOARD OF BALLAST BLOCKS AFT OF WF (196). MINOR CORRSION WAS FOUND ON SHELL PLATE WHERE IT MEETS WF (204). XXX DUE TO NUMEROUS INTERFERENCES, (BALLAST BLOCKS, PIPING, ETC) RECOMMEND PERAIR ACTIVITY REMOVE BALLAST BLOCKS, HALON BOTTLESS AND OTHER INTERFERENCES INCLUDING WORKBENCH, DECKPLATES, BULKHEAD INSULATION IN ITS ENTIRETY FROM FUEL TANK 5-204-2-F AND CONDUCT SURFACE PREP OF ENTIRE BILGE FROM FRAME 195 TO 212 FROM S-9 DOWN TO SSDG MODULE BULKHEAD INCLUDING DECKPLATE SUPPORTSS AFT TOO ESCAPE TRUNK(FR212). PRESERVE ENTIRE FUEL OIL TANK(5-204-2-F) EXTERIOR BULKHEAD IN AUX 1 TO OVERHEAD . FRONTLOAD FOR TANK PLATING REPLACEMENT OF 10 SQ FT FOR THOSE AREAS FOUND DETERIORATED BEYOND LIMITS. REPLACE ALL CONDENSOR SWS PIPING BRACKETS AND FASTENERS AND GAUGE LINE BRACKETS PRIOR TO PRESERVING THIS BULKHEAD. REINSULATE BULKHEAD DOWN TO LEVEL EQUAL TO S-9. WHEN PRESERVATION IS COMPLETE INCLUDE THOSE BALLAST BLOCK RETAINING BRACKETS REMOVED AS INTERFERENCES IN THE PRESERVATION.

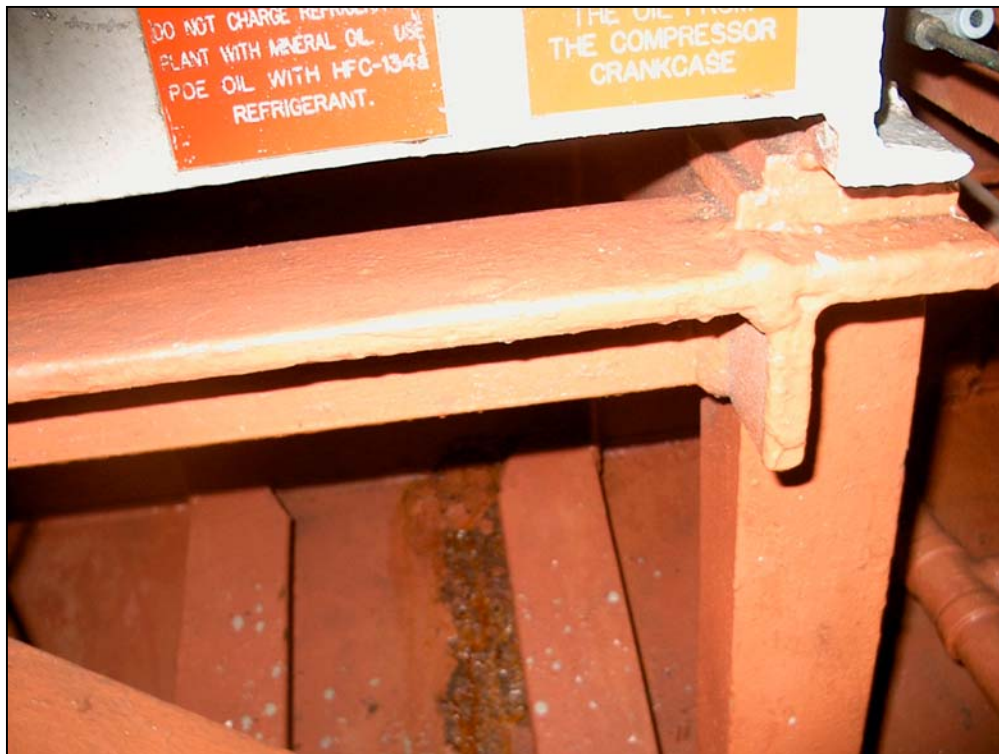
CORROSION ON SHELL BELOW REEFER COMPRESSOR 2  
CSMP A174

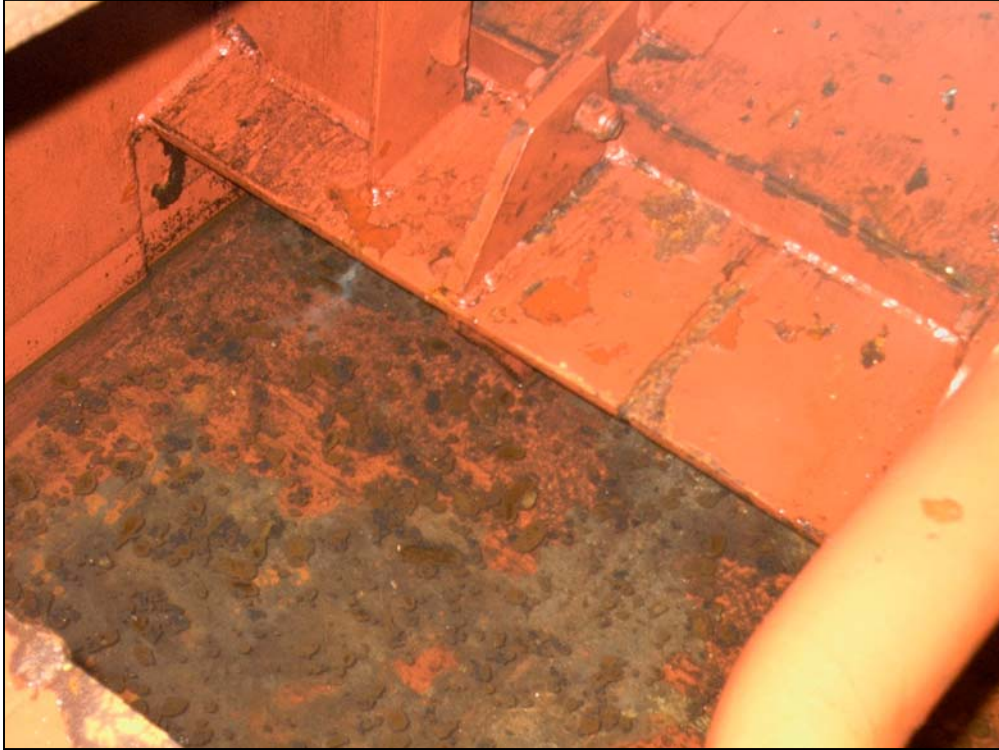
CORROSION AND STANDING WATER OUTBOARD OF ESCAPE TRUNK.  
CSMP A174

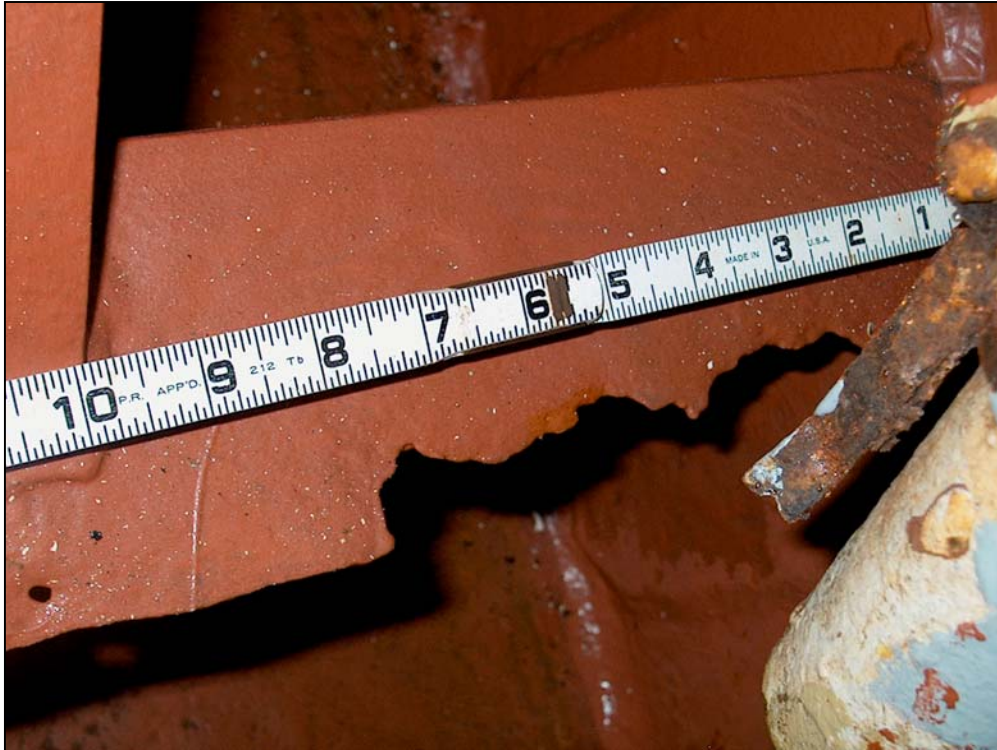
DISCREPANCY DESCRIPTION: PER HM&ERA UNDERWATER HULL ASSESSMENT: 5-51-0-Q FORWARD EDUCTOR ROOM					
PERFORMED U/T SURVEY AS PER CSMP 2733, NO SHELL THINNING WAS FOUND. FLANGE OF STRINGER 1 STBD AT BHD 56 IS DETERIORATED (10X 4 T) 1ST INTERCOSTAL FWD OF BHD 56 IS DETERIORATED.(2X3 T)					
RECOMMENDED REPAIRS: GAS FREE TANK (5-56-0-F) CUT OUT AND REPLACE APPROX 3FT OF S1 STARTING 1FT AFT OF BHD 56, CUT OUT AND REPLACE PORT AND STARBOARD INTERCOSTALS (2X3 T) FROM THE KEEL TO THE 2 <sup>ND</sup> STRINGER, APPROX 16 FT. PRIME AND PAINT AREAS DISTURBED BY REPAIRS. REFER TO NAVSHIPS DRAWING 5534338 REV A					
REWRITE CSMP P020					
SSPORT C221 POC: B. WILLIAMS (757-396-4001 EXT-2166 ) TPOC: C. BUCK					
CSMP SUMMARY: DETERIORATION OF STRINGER & INTERCOSTALS IN 5-51-0-Q				TEST# MRC 1102/1	
ROOT CAUSE/AMPLIFICATION: H1				STEP# 1 THRU 5	
SYSTEM LEVEL IMPACT:					
PART NO.	NOMENCLATURE		QTY	NSN	COST
1					
2

FLANGE OF 1<sup>ST</sup> STRINGER AT BHD 56 STARBOARD SIDE. JSN A410

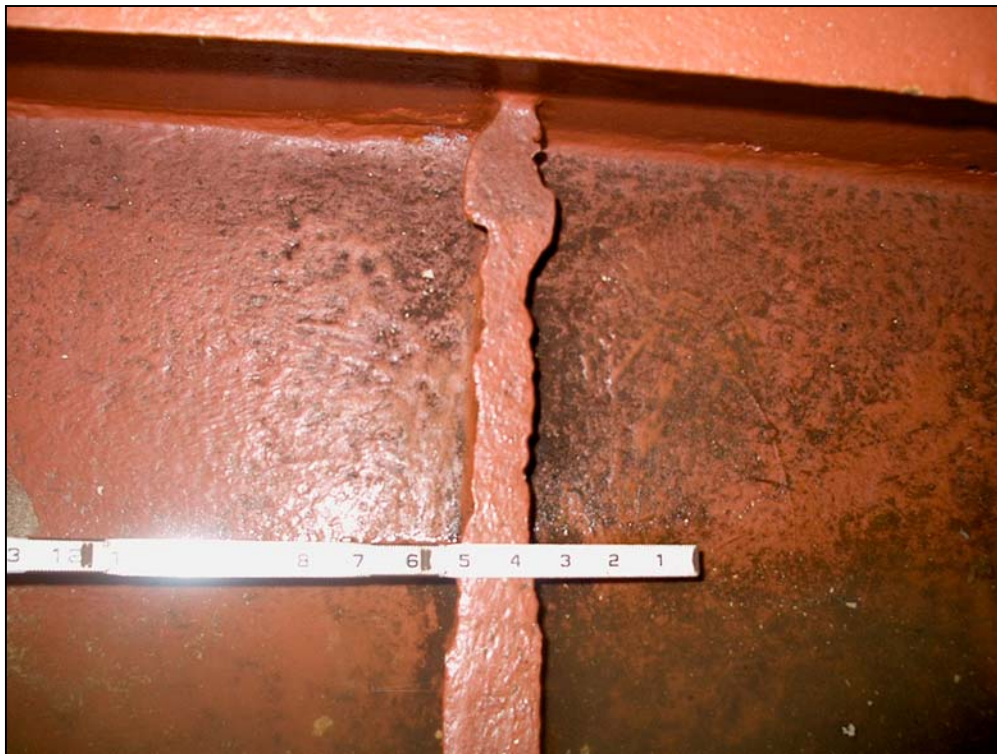
DETERIORATED 2X3 INTERCOSTAL STARBOARD SIDE. JSN- A410

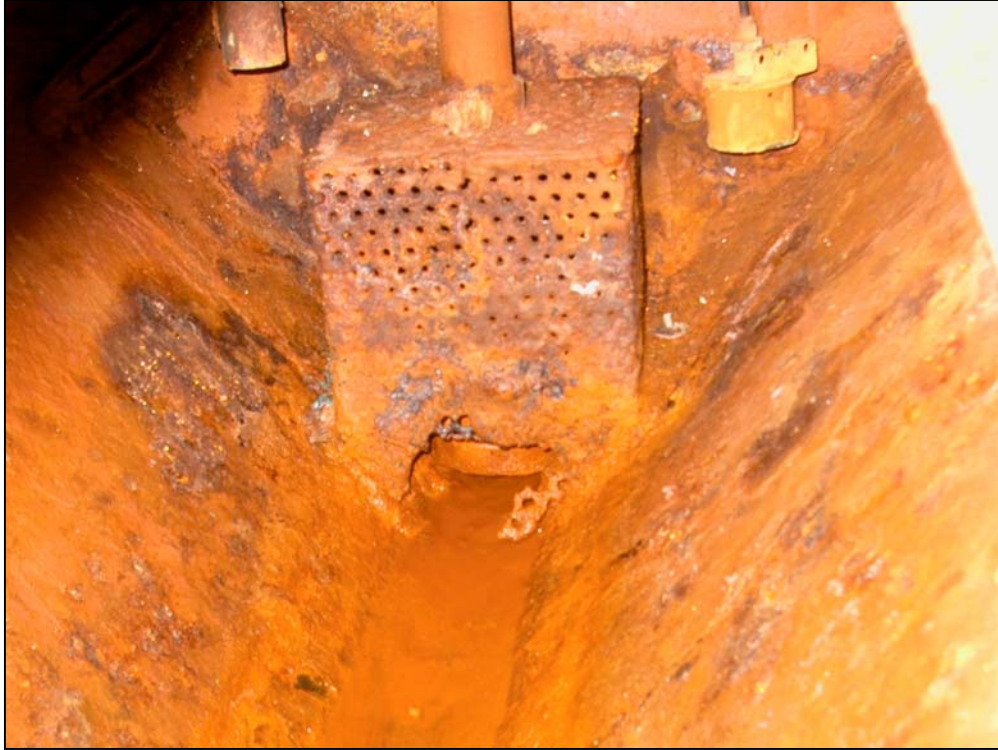
<b>DISCREPANCY DESCRIPTION: PER HM&amp;ERA UNDERWATER HULL ASSESSMENT: 4-100-0-E APU MACHINERY ROOM</b>					
PORT AND STARBOARD BILGE AREAS HAVE HEAVY CORROSION AND PAINT SEPARATION, APPROX. 80 SQFT					
<b>RECOMMENDED REPAIRS: REMOVE PORT AND STARBOARD DECK PLATES, CLEAN AREAS TO BARE METAL, PRIME AND PAINT</b>					
REPLACE DECK PLATES.					
<b>SSPORT C221 POC: B. WILLIAMS (757-396-4001 EXT-2166 ) TPOC: C. BUCK</b>					
<b>CSMP SUMMARY: BILGE CORROSION 4-100-0-E</b>				<b>TEST#</b> MRC 1102/1	
<b>ROOT CAUSE/AMPLIFICATION:</b> H1				<b>STEP#</b> 1 THRU 5	
<b>SYSTEM LEVEL IMPACT:</b>					
PART NO.	NOMENCLATURE		QTY	NSN	COST
1					
2					
3					
4					
5					
6					
FIRST CONTACT GUEVERA		RATE DC1	SECOND CONTACT REYES		RATE DCC
ASSESSOR / ACT / TECH ID# J. LAROCK QED SYSTEMS INC		TD	TL	LOGISTICIAN	TSP

CORROSION IN PORT BILGE. JSN A 347

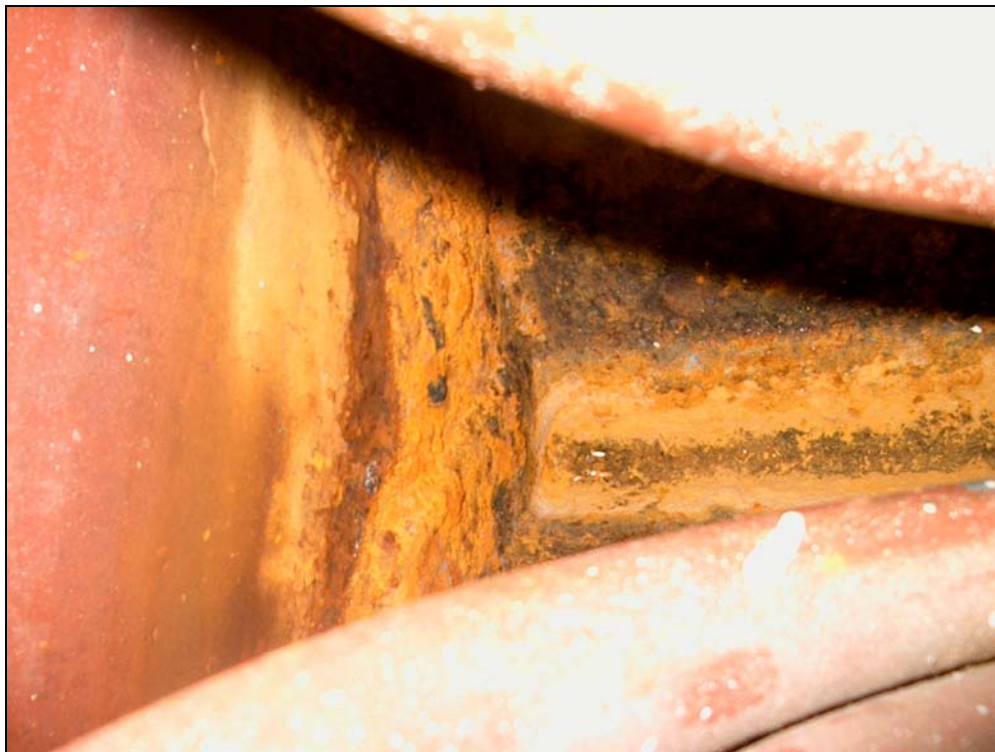
CORROSION IN STARBOARD BILGE AT BHD 100. JSN A347

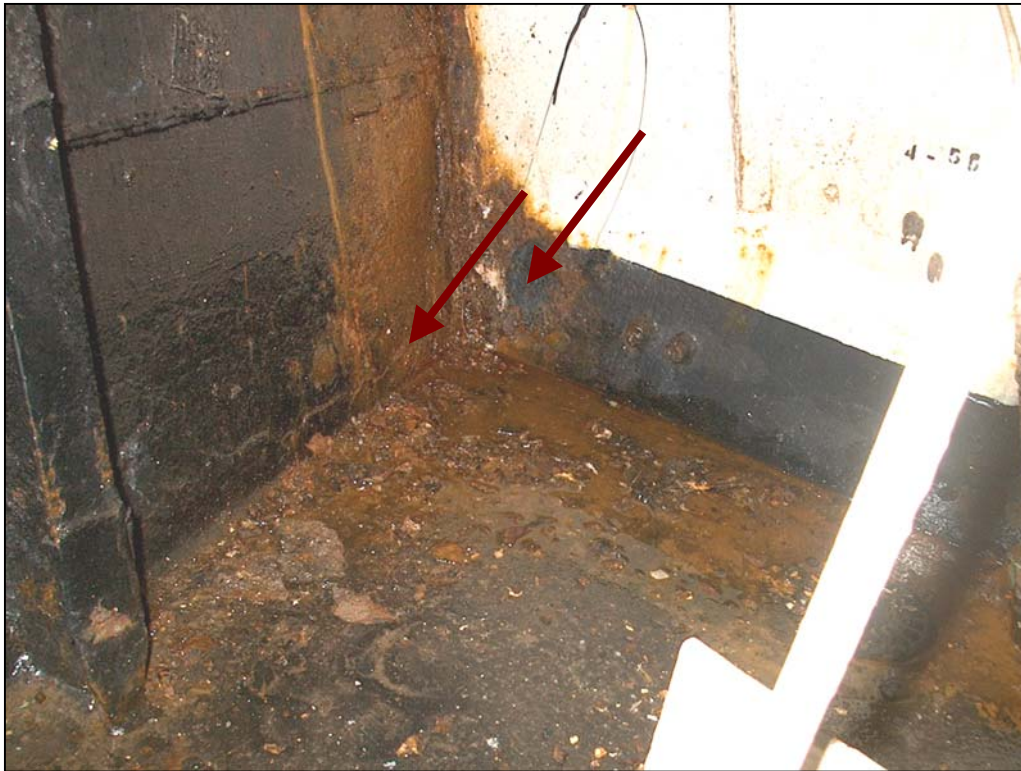
DISCREPANCY DESCRIPTION: PER HM&ERA UNDERWATER HULL ASSESSMENT: 4-48-1-Q SONAR COOLING EQUIPMENT ROOM					
THE 2 <sup>ND</sup> STRINGER FROM THE DECK AT BHD 56 IS DETERIORATED, BHD 56 IS THINNED BELOW THE 25% WASTAGE CRITERIA WHERE IT MEETS THE DECK AND SHELL. THE SHELL IS THINNED BELOW THE 25% WASTAGE CRITERIA AT BHD 56. THE HULL INSULATION IS SATURATED FROM THE 3 <sup>RD</sup> STRINGER TO THE OVERHEAD.					
RECOMMENDED REPAIRS: CUT OUT APPROX. 4FT OF THE 2 <sup>ND</sup> STRINGER STARTING FROM 1FT AFT OF BHD 56 (4-56-0-M SMALL ARMS MAG) 8X 4 T BEAM, CUT OUT AND REPLACE APPROX. 4 SQFT OF BHD 56 FROM THE SHELL TO 1FT INBOARD AND 4FT UP FROM DECK (.250 OS) CUT OUT AND REPLACE APPROX. 16SQFT OF SHELL PLATING (.375 OS) STARTING FROM 8" AFT OF BHD 56 TO 4FT FWD. REMOVE ALL HULL INSULATION. REMOVE CORROSION, PRIME AND PAINT USING AN ANTI-SWEAT COATING. REFER TO NAVSHIPS DRAWING 5534338 REV A

STARBOARD SHELL AND BULKHEAD 56. ARROWS INDICATE LOW U/T READINGS.  
REFER TO DRAWINGS FOR MEASUREMENTS. A411

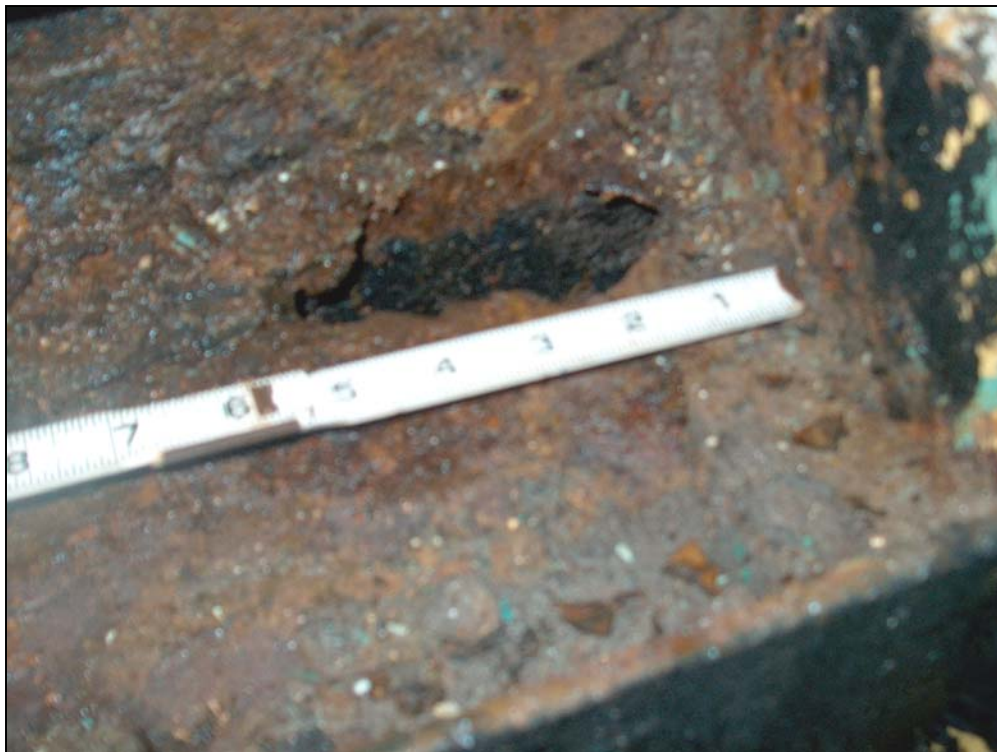
2<sup>ND</sup> STRINGER FROM THE DECK AT BULKHEAD 56. A411

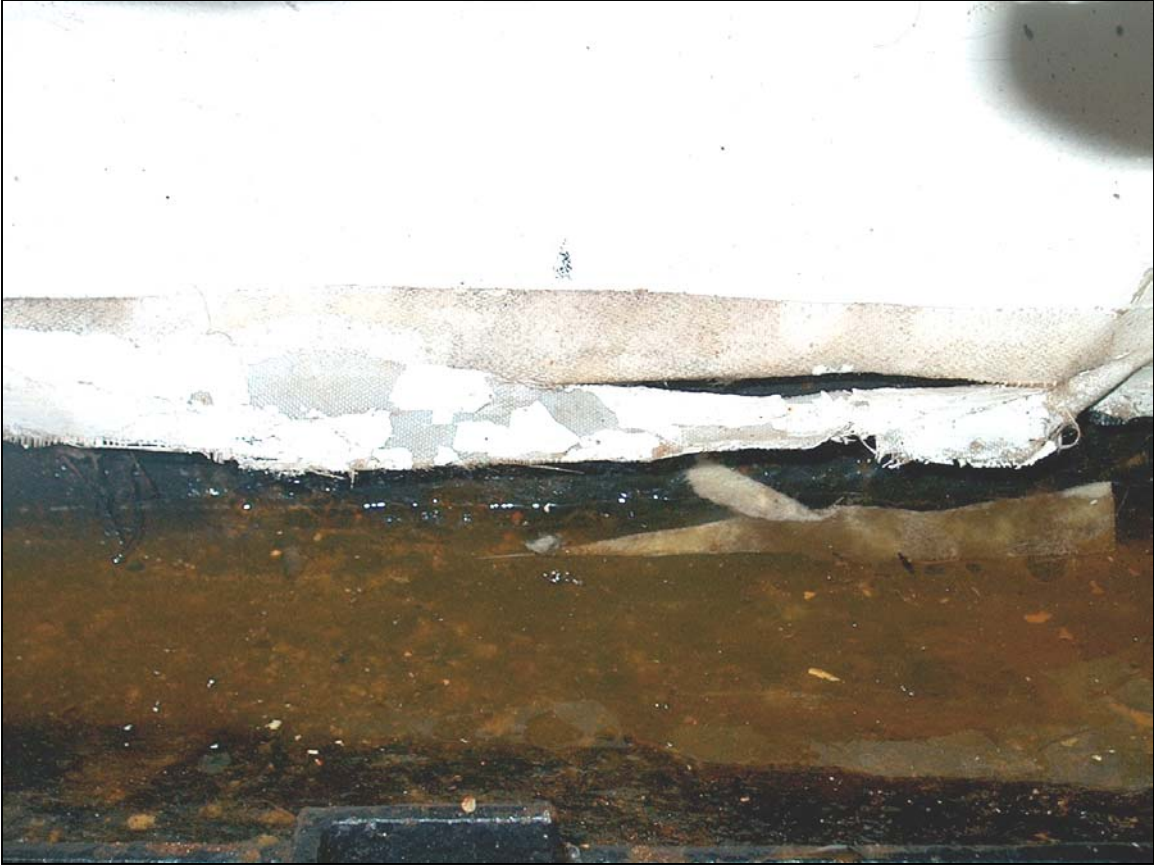
WATER TRAPPED IN THE STRINGERS HAS SATURATED THE HULL INSULATION AND CAUSED SERIOUS CORROSION. THE PERMANENT REMOVAL OF THE INSULATION IS RECOMMENDED. THIS IS A COMMON AREA OF CORROSION ON THE (FFG-7) CLASS. JSN-A411

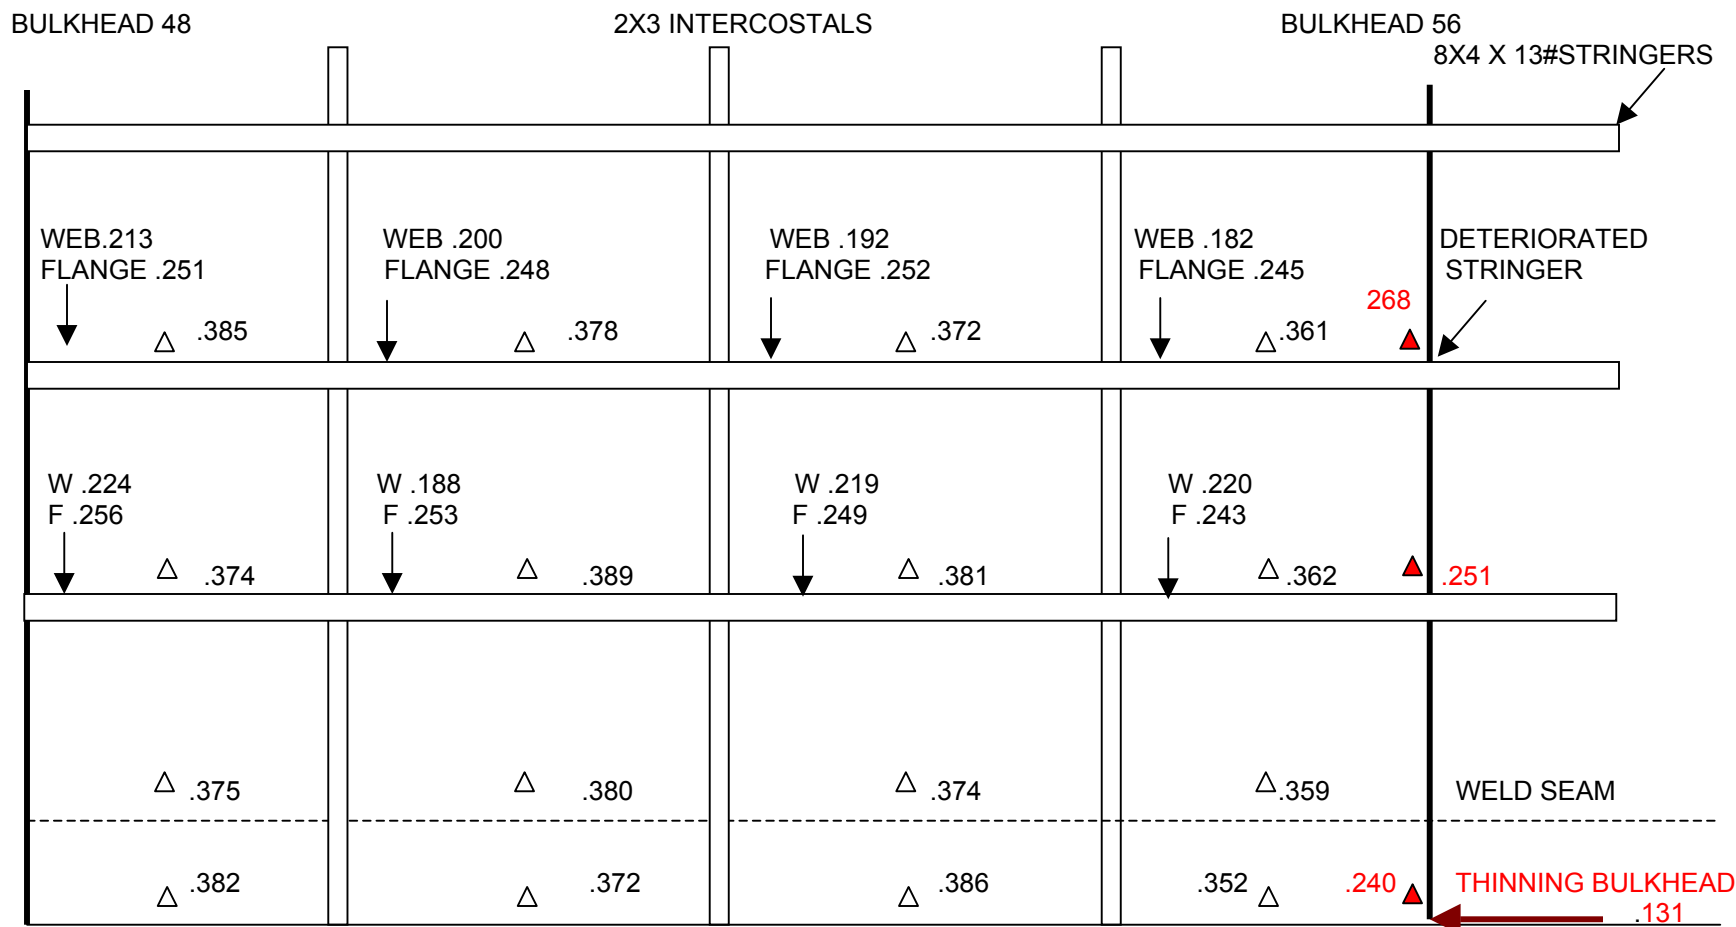
SHELL DESIGN THICKNESS .375  
 MINIMUM .282  
 STRINGER WEB DESIGN .230  
 FLANGE .255

RED DENOTES UNSATISFACTORY READINGS
